Human Life Takes Precedence!

Mains disturbance analyzers from
Gossen Metrawatt assure steady supply power.

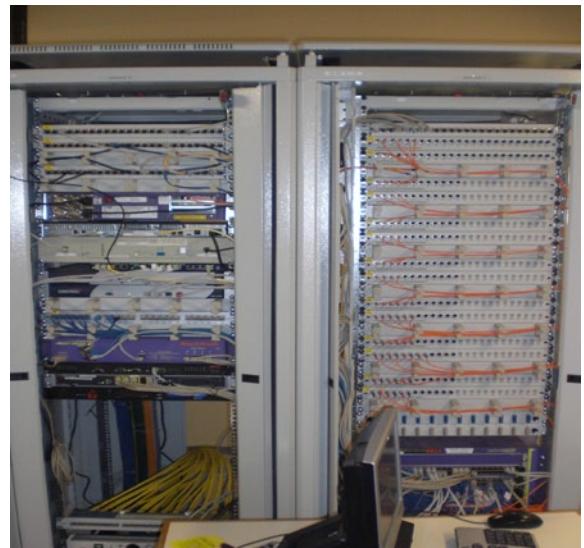
Central Server at the Clinic

This decision was the result of sporadic failures of the UPS of the central server. As is the case with nearly all modern enterprises, there's a central server at Forchheim Clinic as well. It controls and monitors processes, and allows for communication. However, its essential advantage is the central concentration of data records. Information which is stored here can be accessed locally at any time in a decentralized fashion from a slave server. If the doctor needs an x-ray image of patient X or patient Y's medical record, he never needs to leave his desk – the required data is displayed at his PC. Of course the individual servers communicate with each other, exchange information and transfer data records. It usually takes several minutes until the data have been written to the hard disk from buffer memory. In the event that a computer is switched off or shut down improperly (e.g. due to power failure), the data records are usually lost irretrievably. For this reason, the servers are backed up with UPS systems (uninterruptible power supply).

The server at the clinic was also connected to a UPS, but sporadic failures occurred nevertheless from time to time. The restart procedure was quite time consuming (20 to 30 minutes), because all of the servers first had to be started and then the database had to be reloaded. No new patients could be added to the database during this procedure, and the doctors lost valuable time as a result.

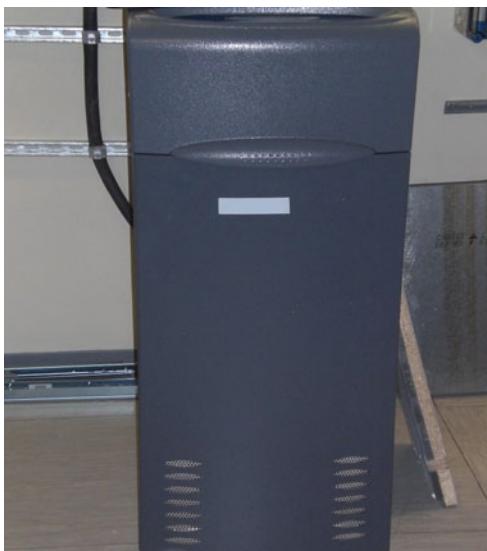
The Culprit: the UPS System

Measurement was then performed on the system with the Mavowatt 40. Based on his measurement results, Thomas Müller determined that the problem originated in the UPS. A second measurement was performed together with representatives from the UPS manufacturer. A defect in the UPS system's control PCB was detected on the basis of measured voltage characteristics. The component was replaced by the manufacturer free of charge. As of this point in time, no further failures have occurred.

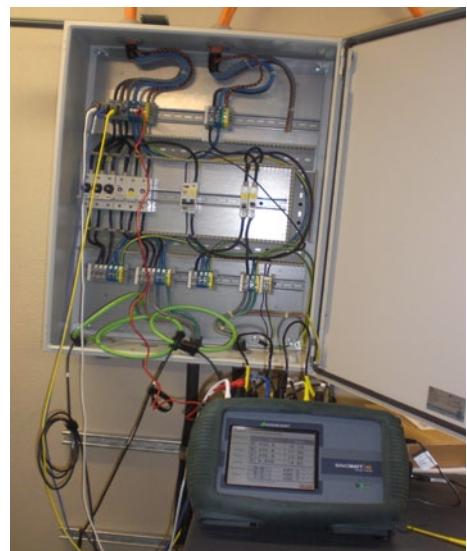
Mavowatt 40 in Action: Measurement at the UPS System's Distributor
